## Cannot add KE to CCKM

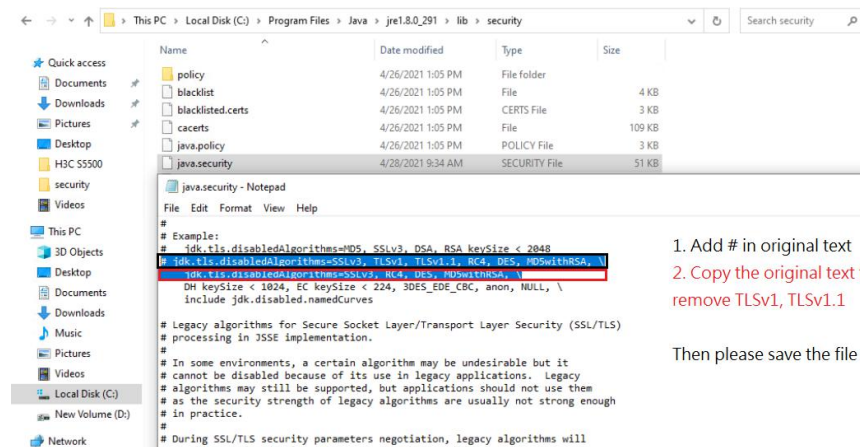
1. Java : from Java 8 update 291, Java adds TLSv1 and TLSv1.1 in disabled algorithms and the two are utilized in many of our over IP products and KE devices.

B. Modify "java.security" as below

1. Add # in original text
2. Copy the original text to next column, remove # and remove TLSv1, TLSv1.1

On Java 8 update 291 or newer version: Modify java.security by removing TLSv1 and TLSv1.1 in disabled algorithms.

Then please save the file and reboot the server.

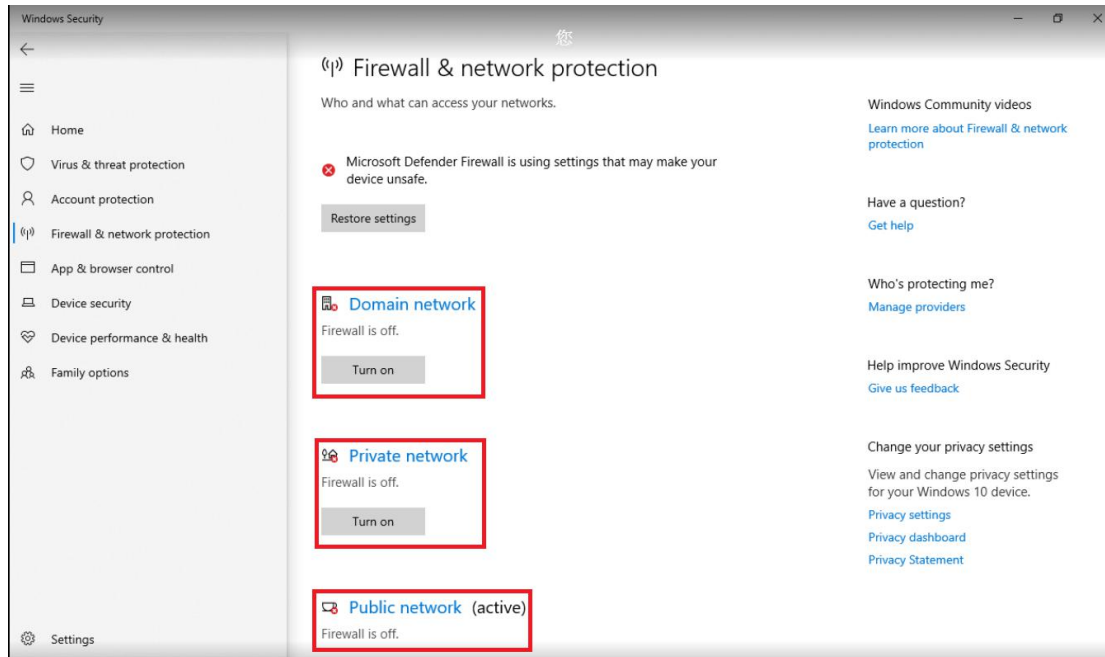
## 2. Firewall or Antivirus blocks necessary ports:

Initially we suggest temporarily turn off Windows firewall and disable antivirus.

You may open below ports for CCKM and KE if firewall and antivirus are needed to enable. Please refer to page 135 of user manual:

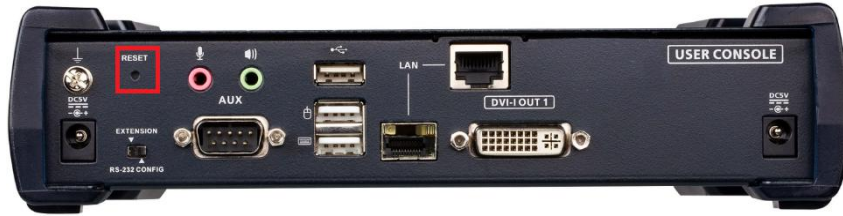
3. If you still cannot add KE to your CCKM after above two measures, please hard reset your KE device then check again: you can power up your KE device, then using end of a paper clip, press and hold the reset button for about 5 seconds until you hear a beep sound. On standard version KE device, the reset button is in the rear of device. For example, below diagram is from KE6900AR:
